EVALUATION OF DOW CHEMICAL PRODUCTION EXTRUDED TRUSS-WEB LANDING MAT

D. W. White, Jr.

March 1974

Conducted by U. S. Army Engineer Waterways Experiment Station
Soils and Pavements Laboratory
Vicksburg, Mississippi

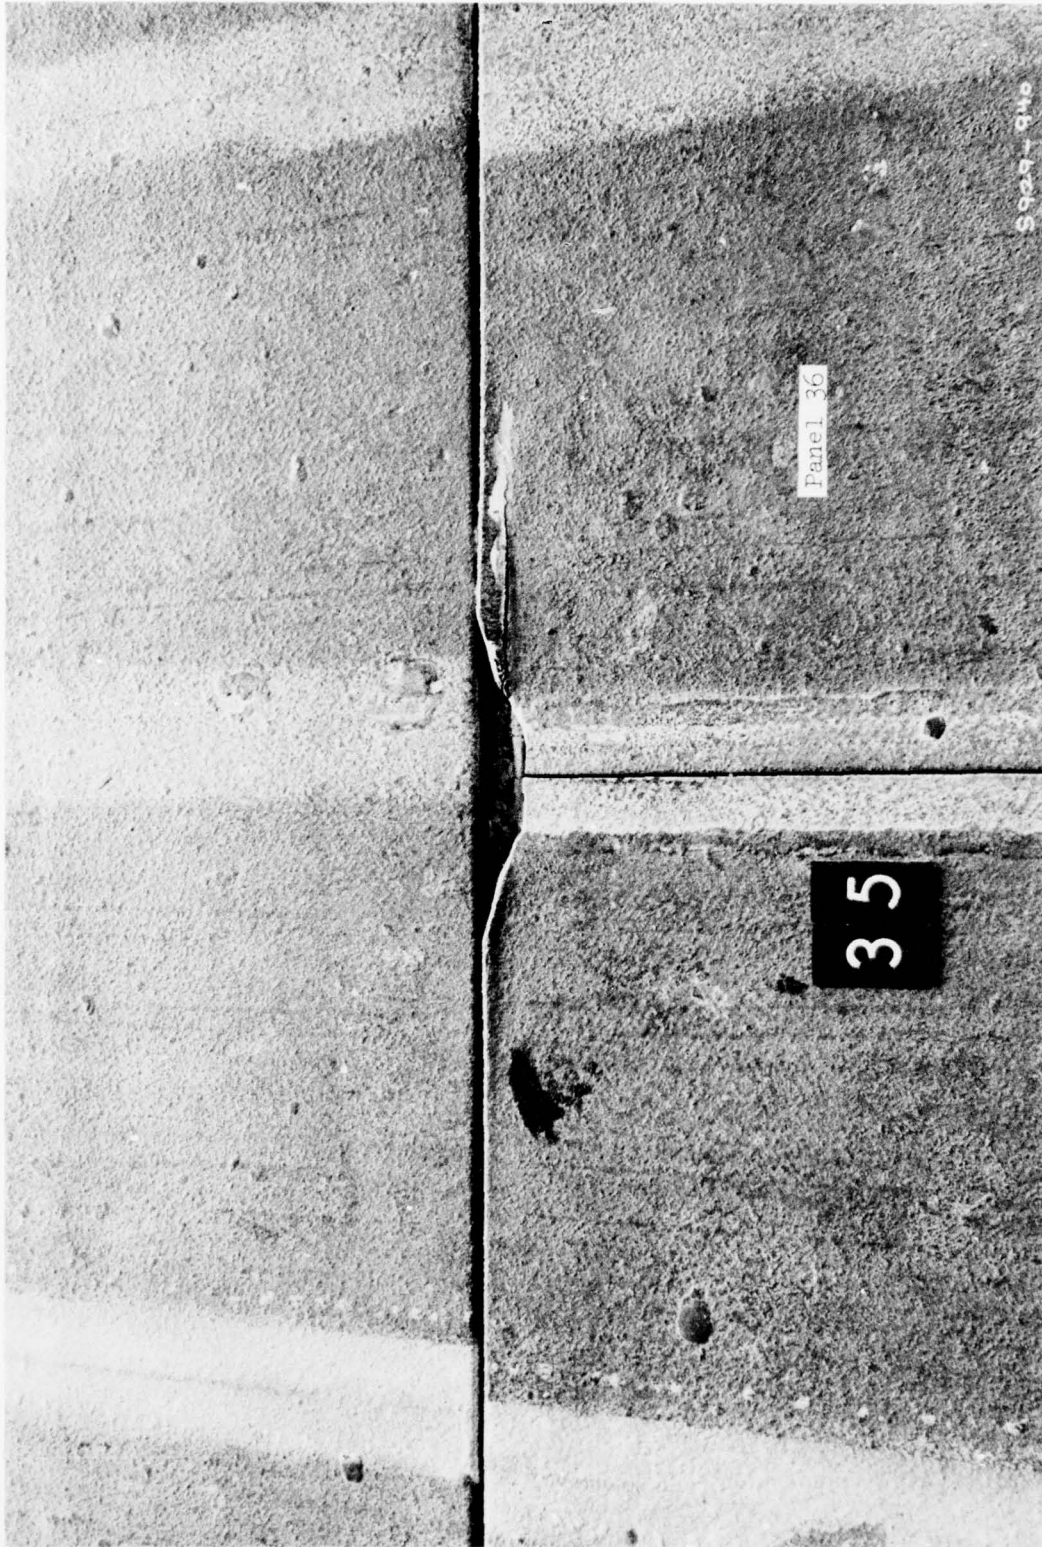
Split in the female connector of panel 36 after 832 coverages, Phase 2

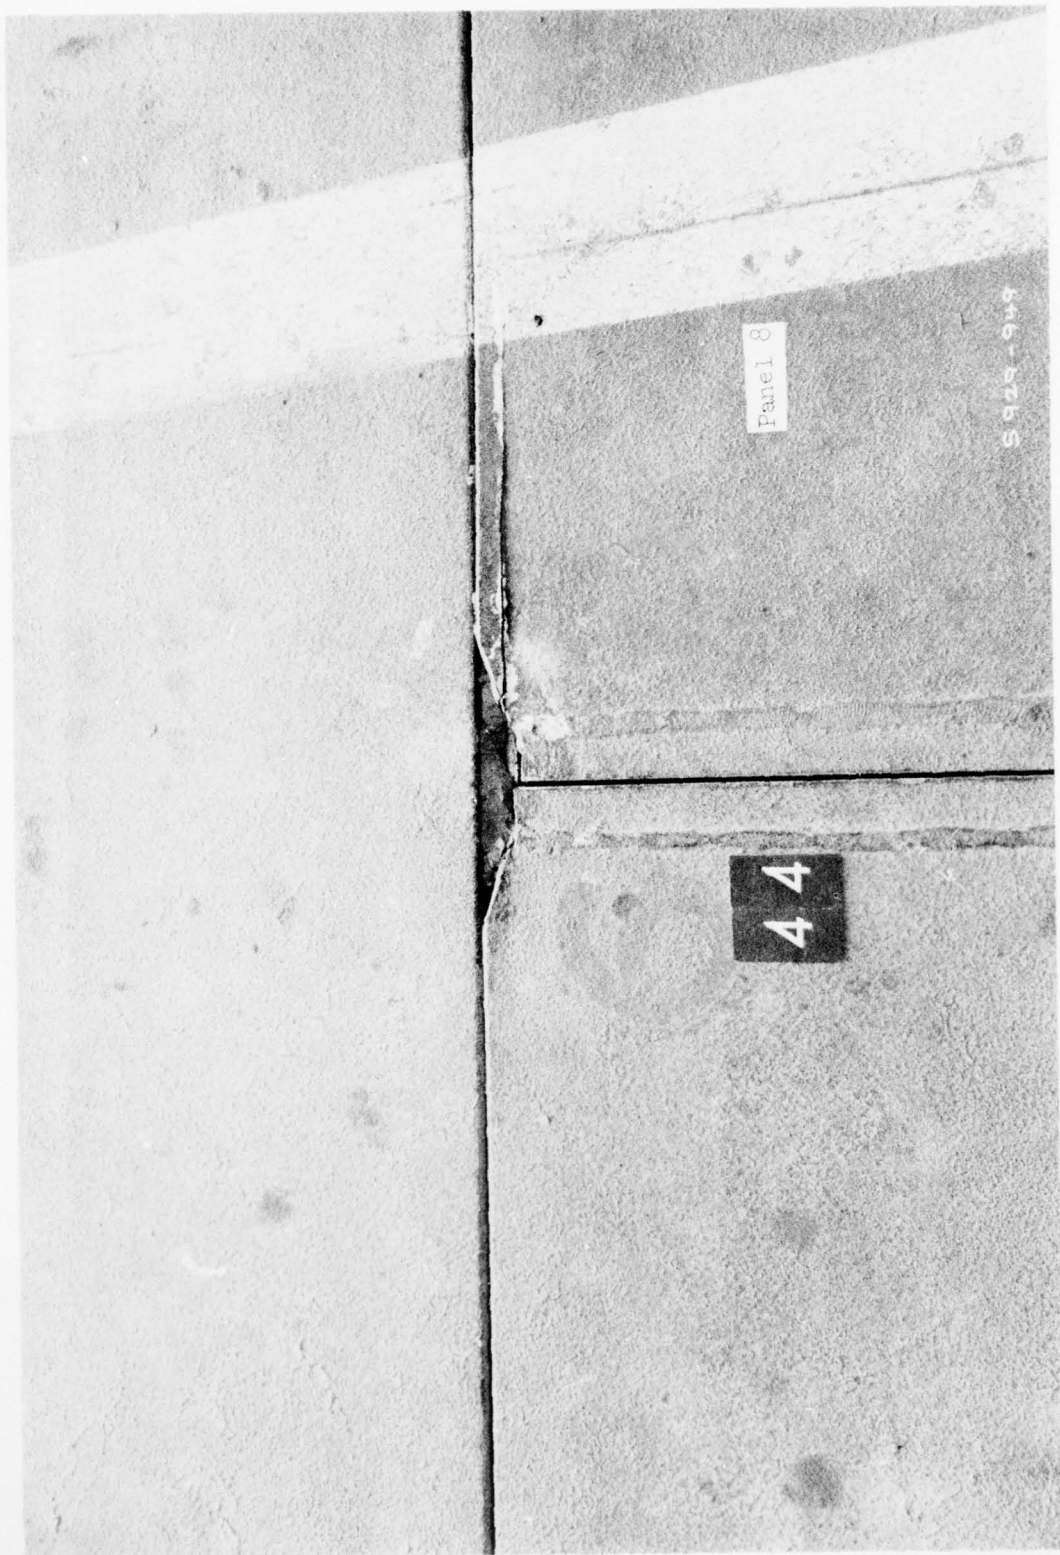
hazards at the female I-lock (Incl 67) and male I-lock (Incl 68) corners. The length of the split along the female connector was 7-3/4 in. The edge of the female connector had turned up, thus exposing sharp edges and the sharp end of the taper where it separated from the panel. The end of the I-lock connector also had turned up, thus exposing the sharp edges in the weld crack. Four other panels (panels 4, 13, 28, and 38) had splits along the female connector at the corner; however, none of these were tire hazards. The longest split was in panel 4 and it was 6-1/8 in. long (Incl 69). This split was at the west end of the panel (see Incl 36). Two panels (panels 18 and 38) had short cracks in the weld at the male side of the panels.

Split in female connector of panel 8 after 210 coverages, Phase 2, subgrade reprocessed

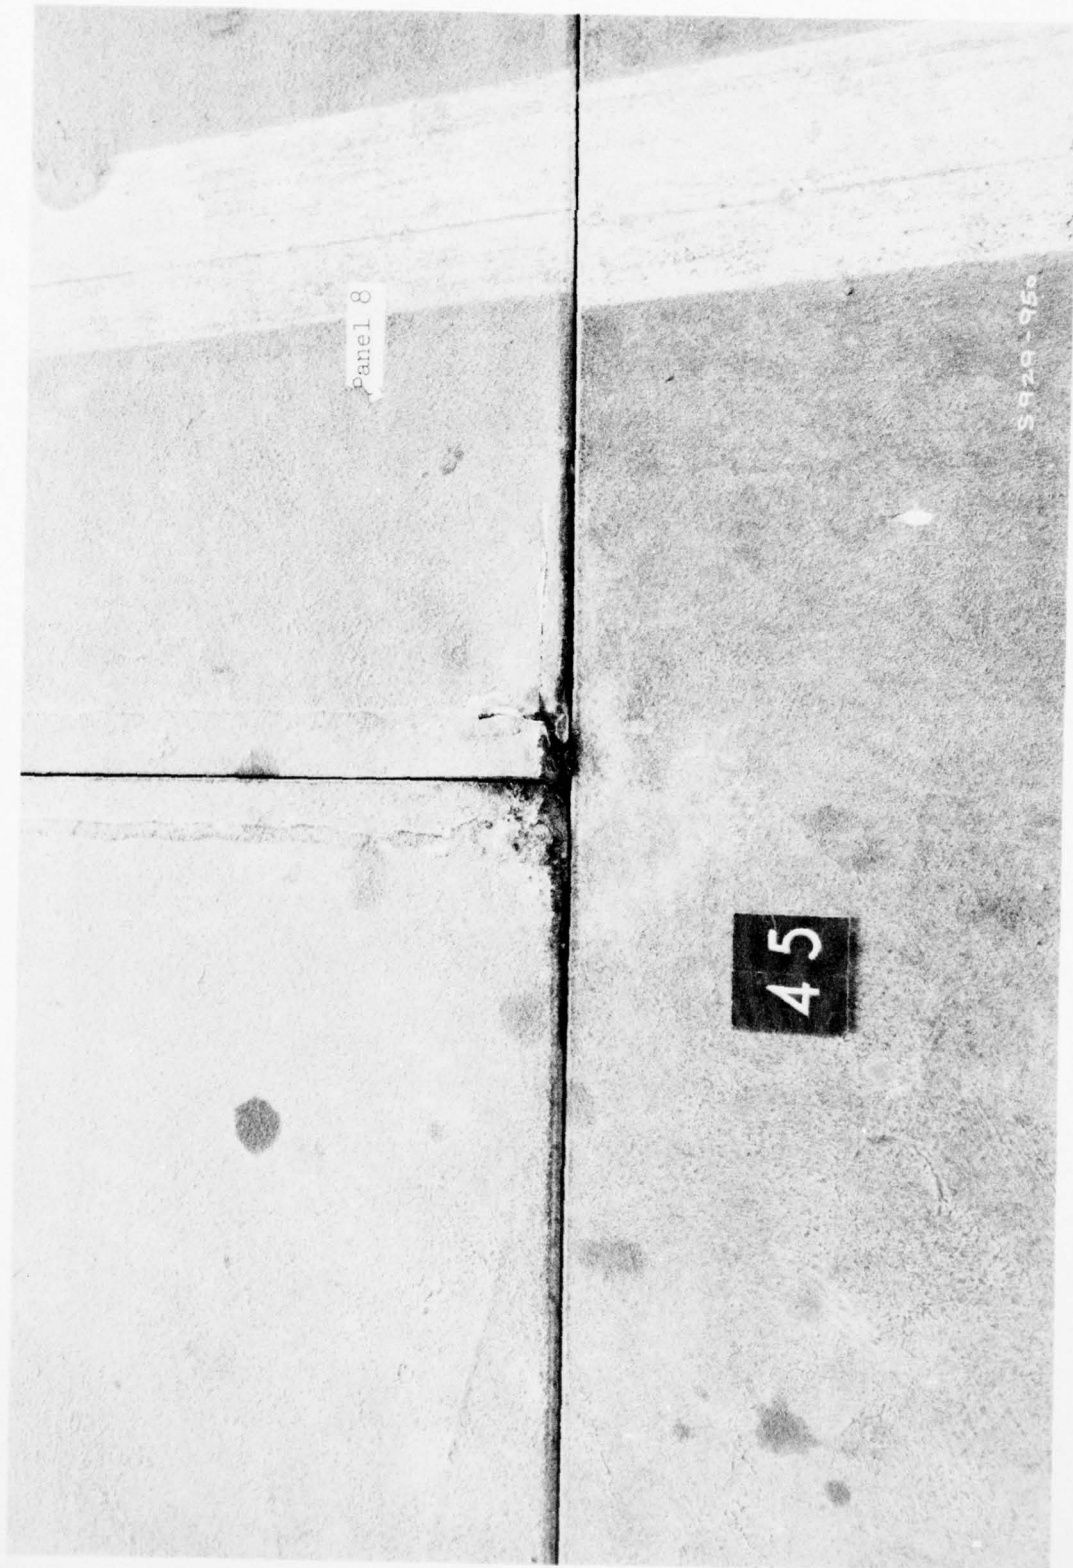
Crack in weld between I-lock and extrusion and split along male connector of panel 8 after 210 coverages, Phase 2, subgrade reprocessed

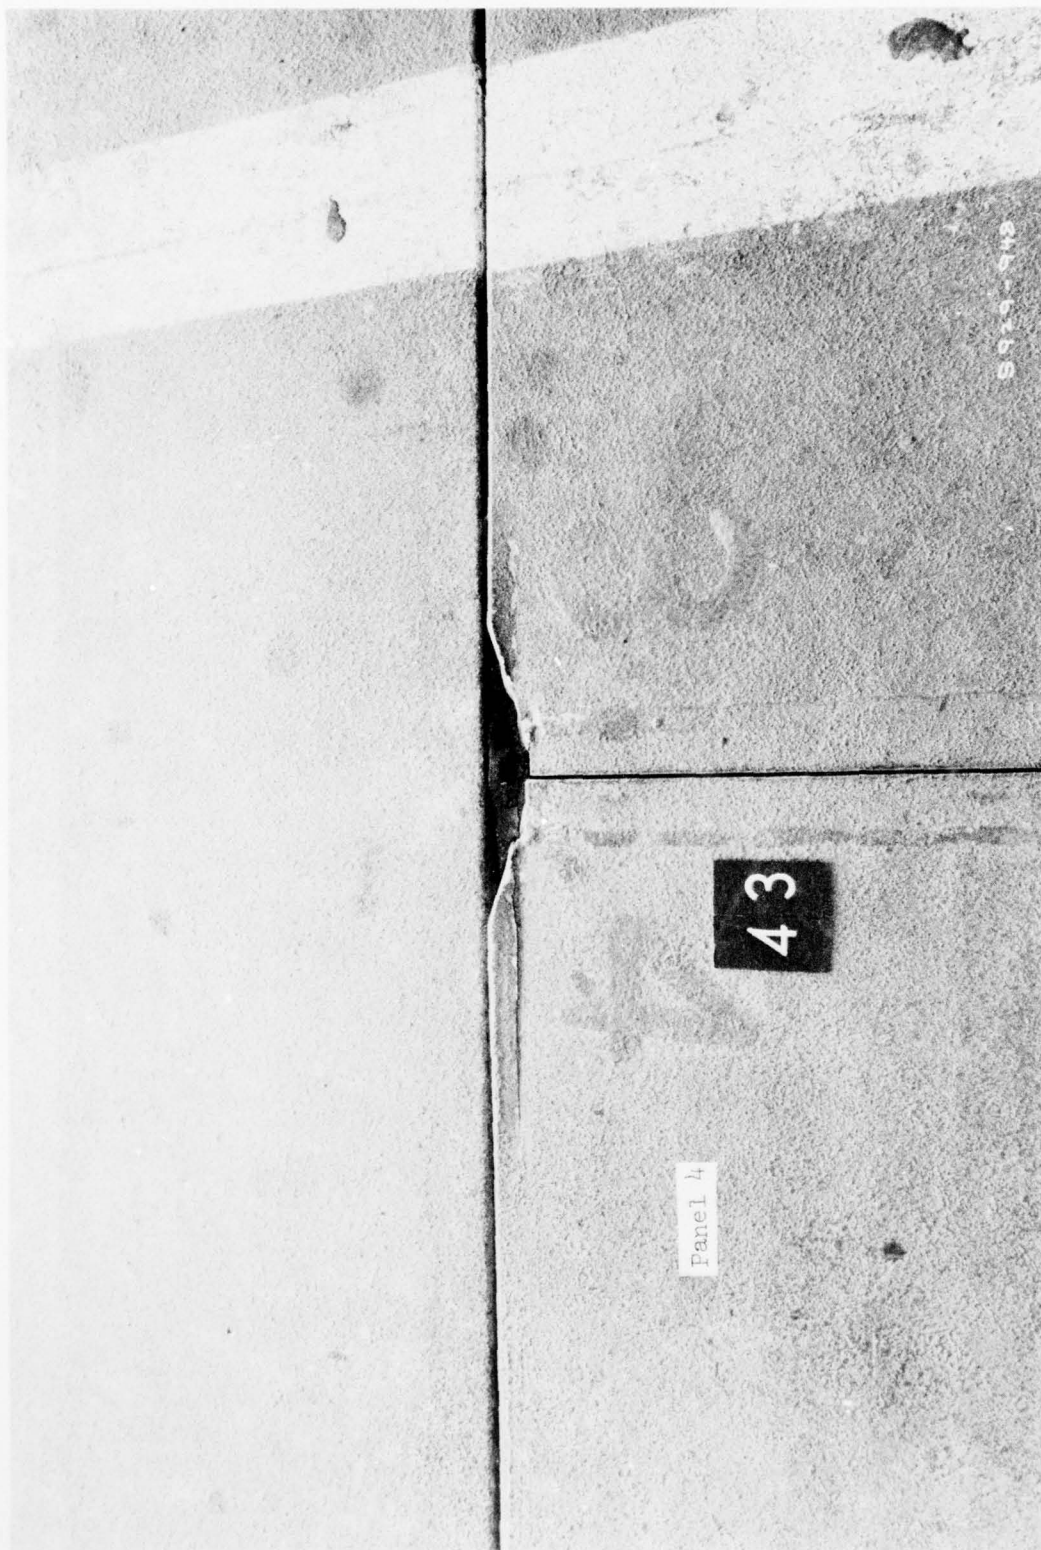
Split in female connector (west end) of panel 4 after 210 coverages, Phase 2, subgrade reprocessed

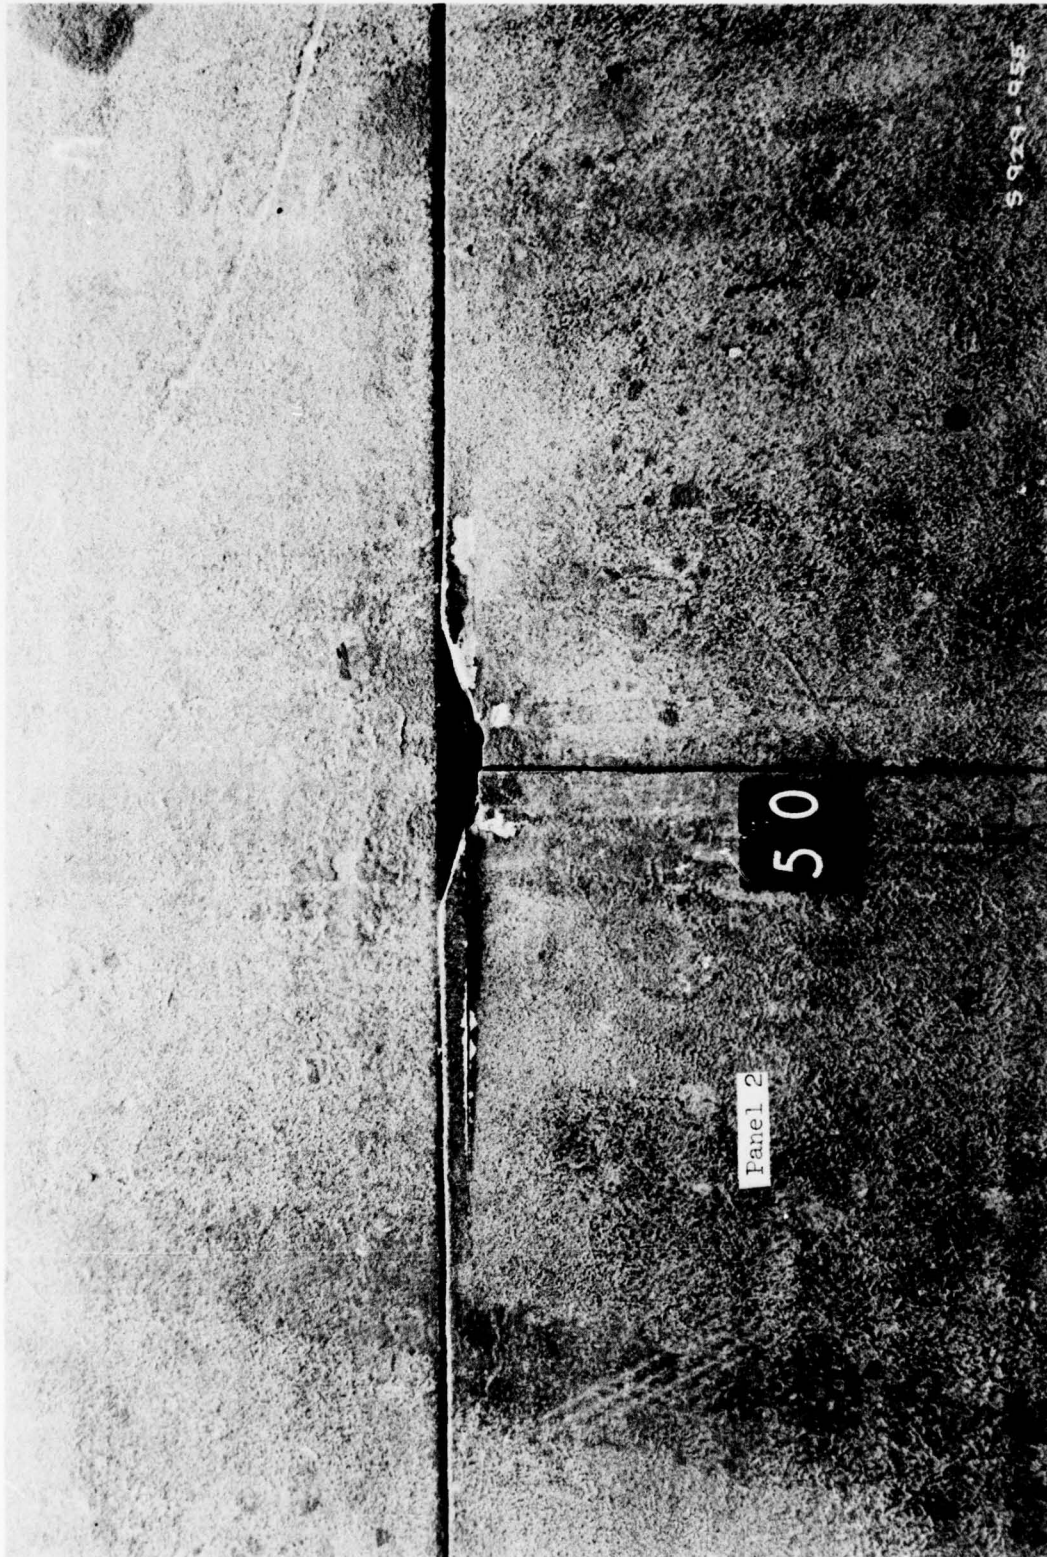
Split in female connector of panel 2 after 300 coverages, Phase 3

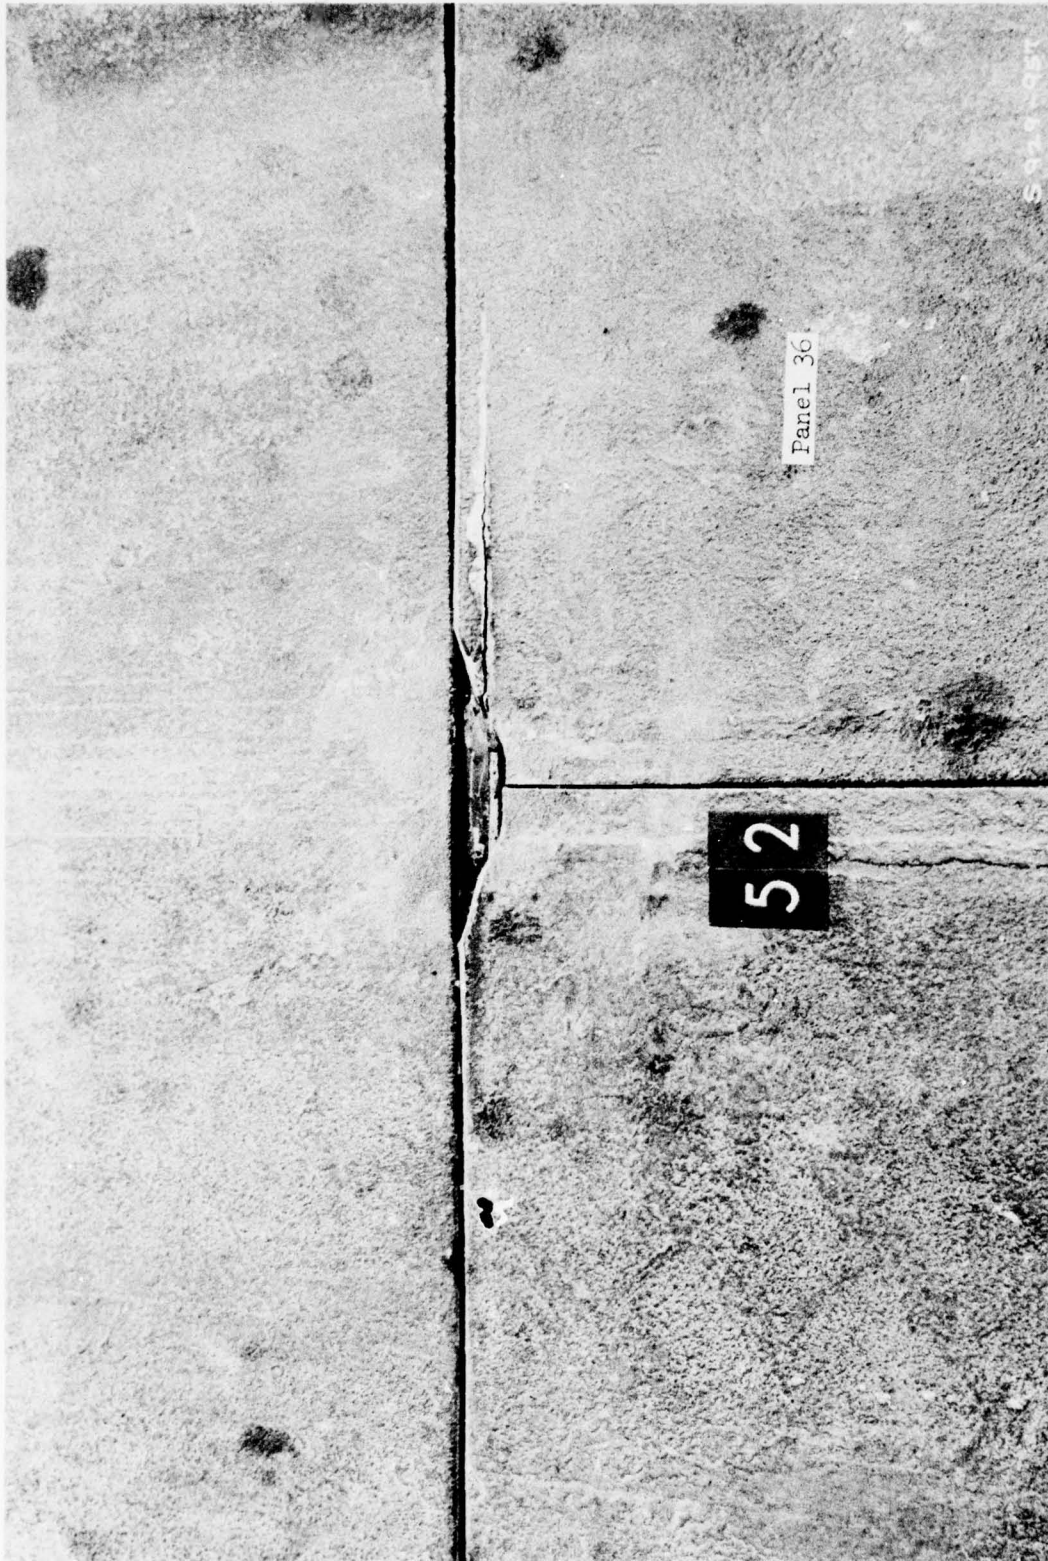
Split in female connector of panel 36 after 300 coverages, Phase 3

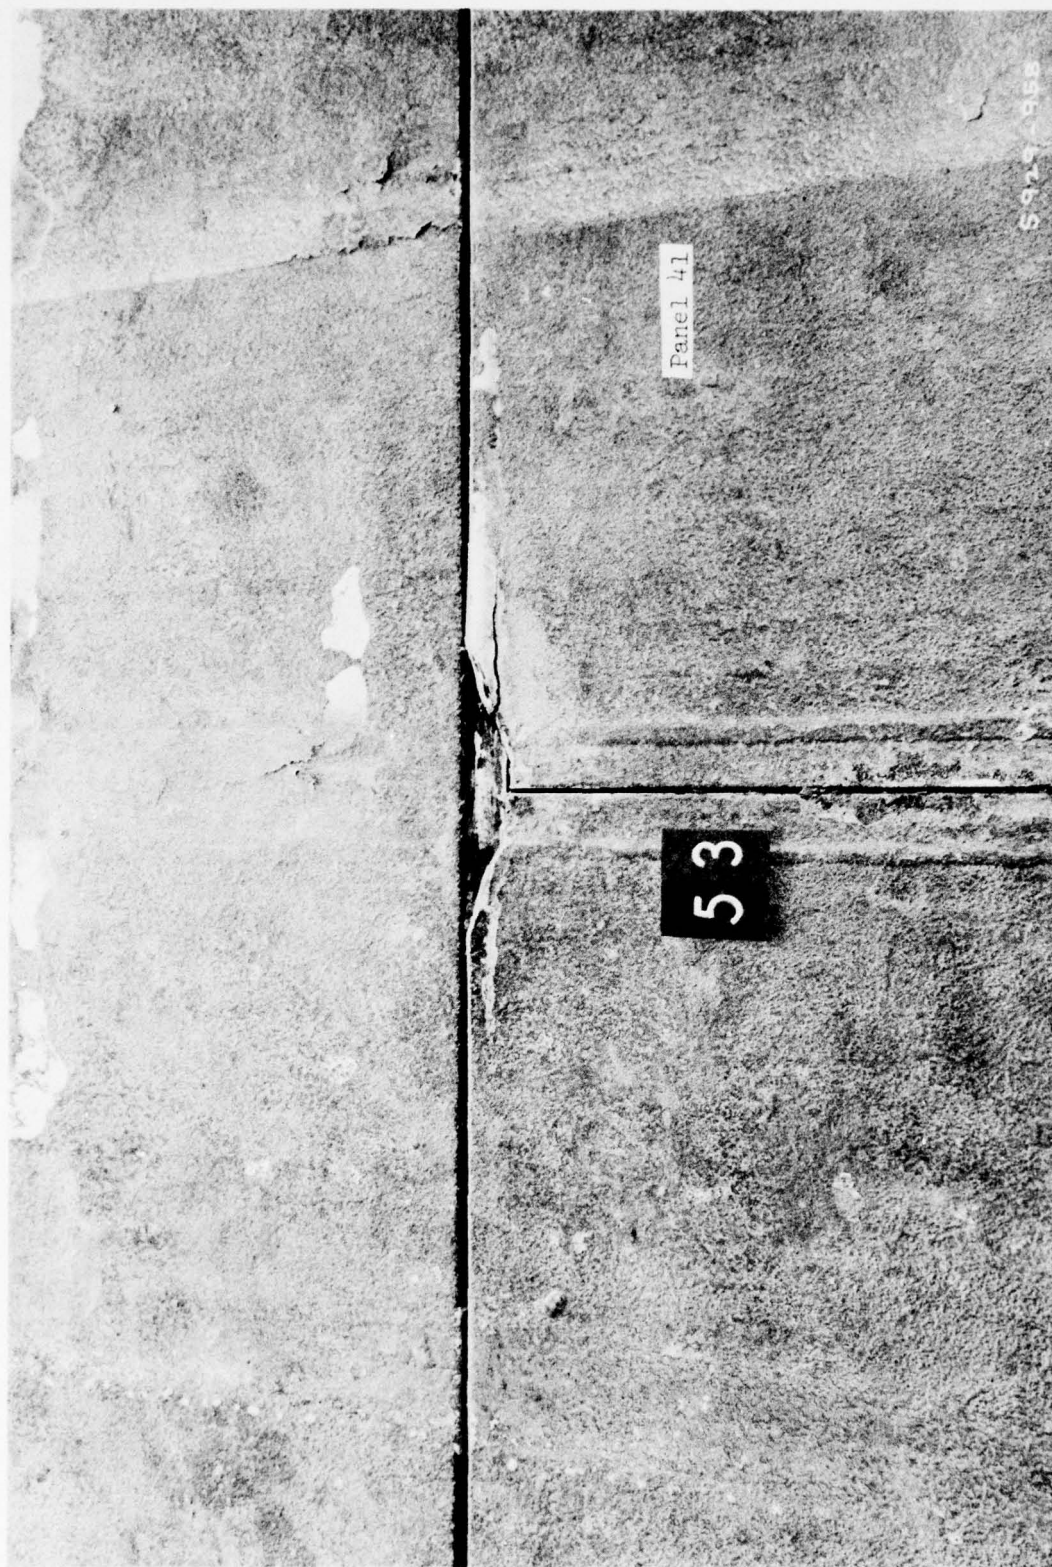
Split in female connector of panel 41 after 300 coverages, Phase 3

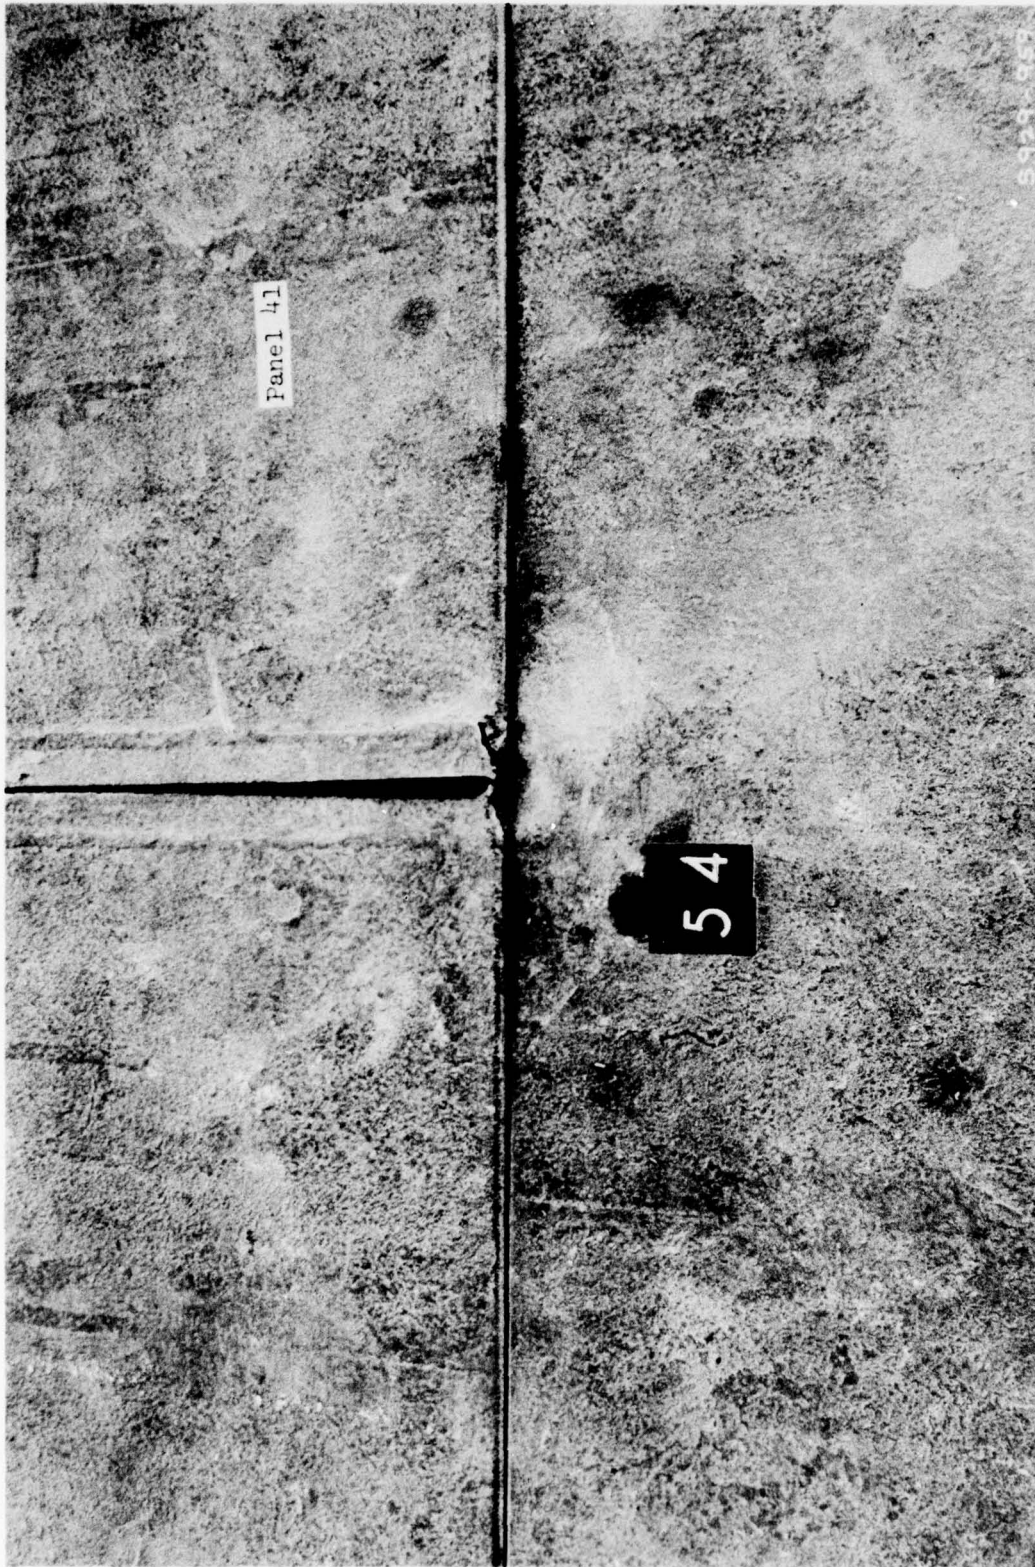
Crack in weld between I-lock and extrusion at male side of panel 41 after 300 coverages, Phase 3

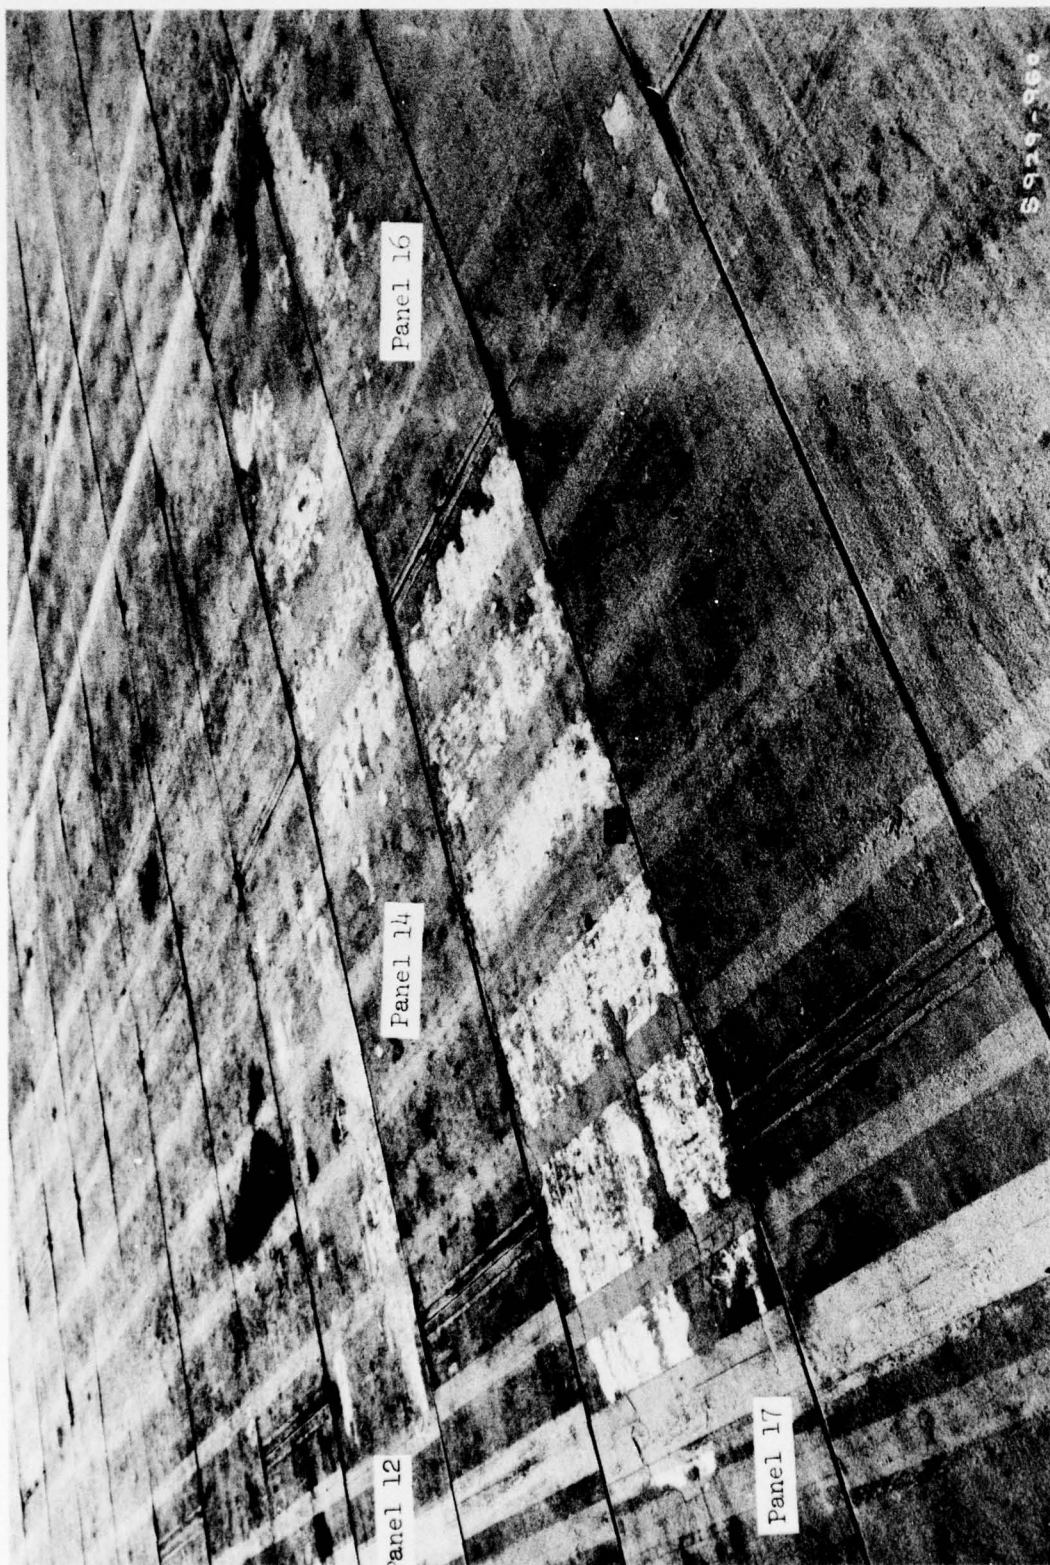
material had come off. Inclosure 77 shows the condition of the antiskid on panels 12, 14, 16, and 17 at the end of testing. In comparison with Incl 44, the majority of the antiskid material that came off these panels did so in the first 500 coverages of Phase 1. Several other panels had small areas where the antiskid had flaked off due to the load wheel and the action of the drive wheels of the load cart/prime mover.

Condition of antiskid on panels 12, 14, 16, and 17 at the end of traffic

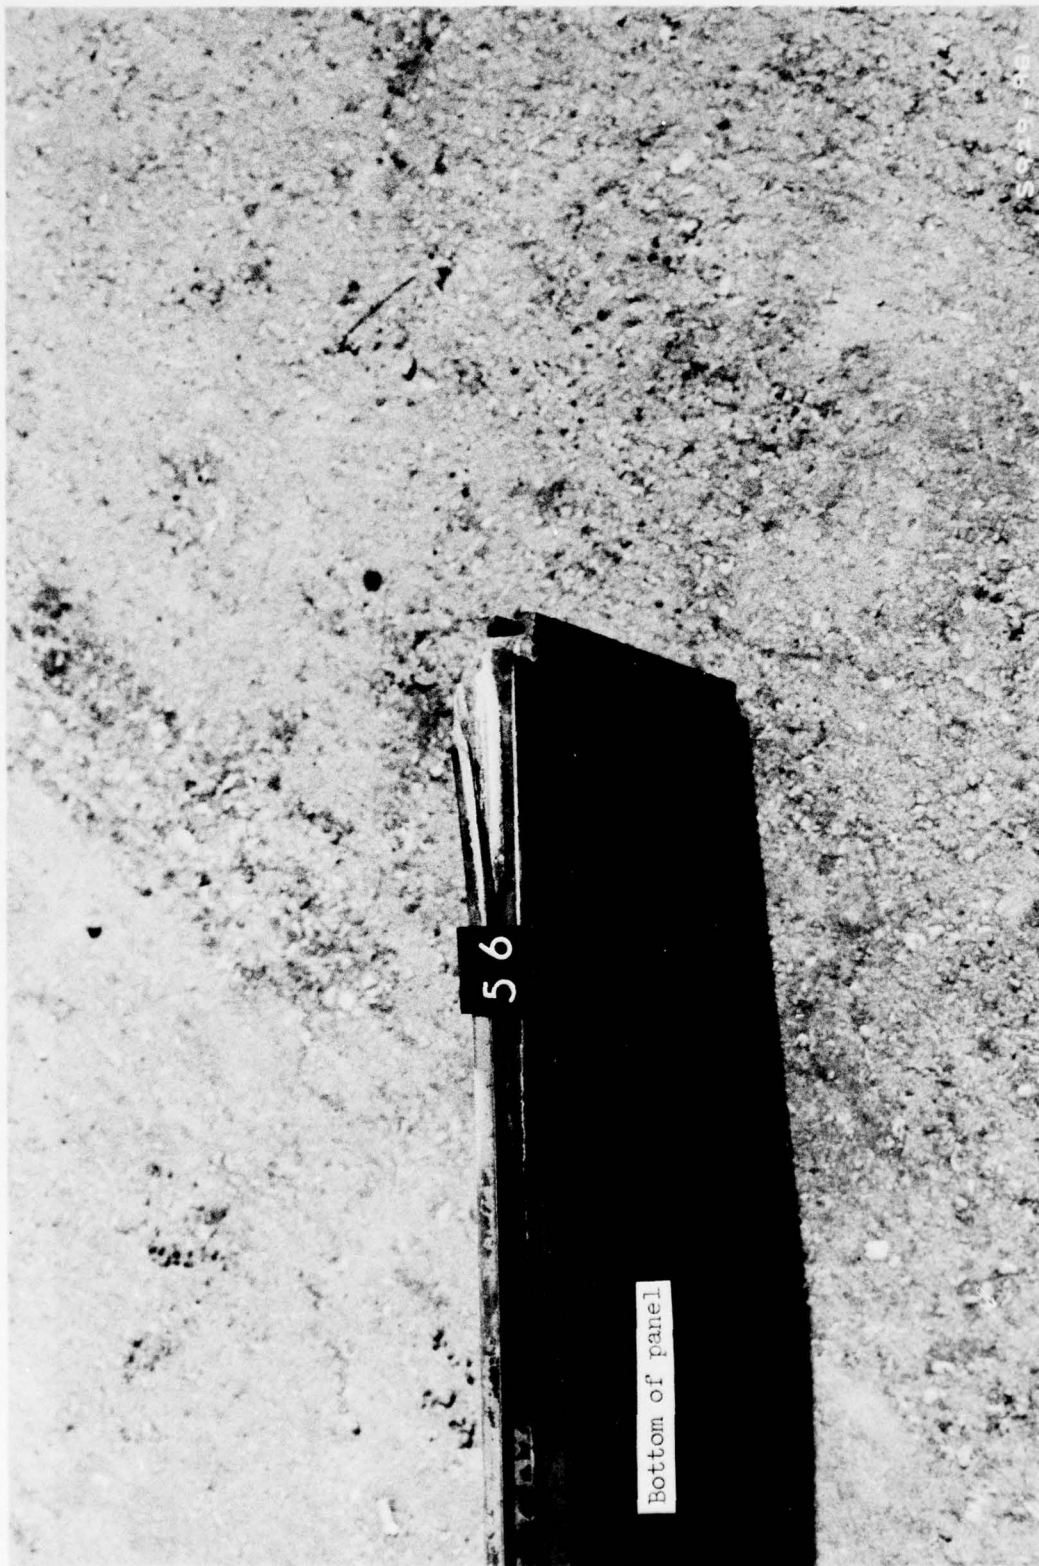
Typical panel failure due to a split at the female I-lock corner

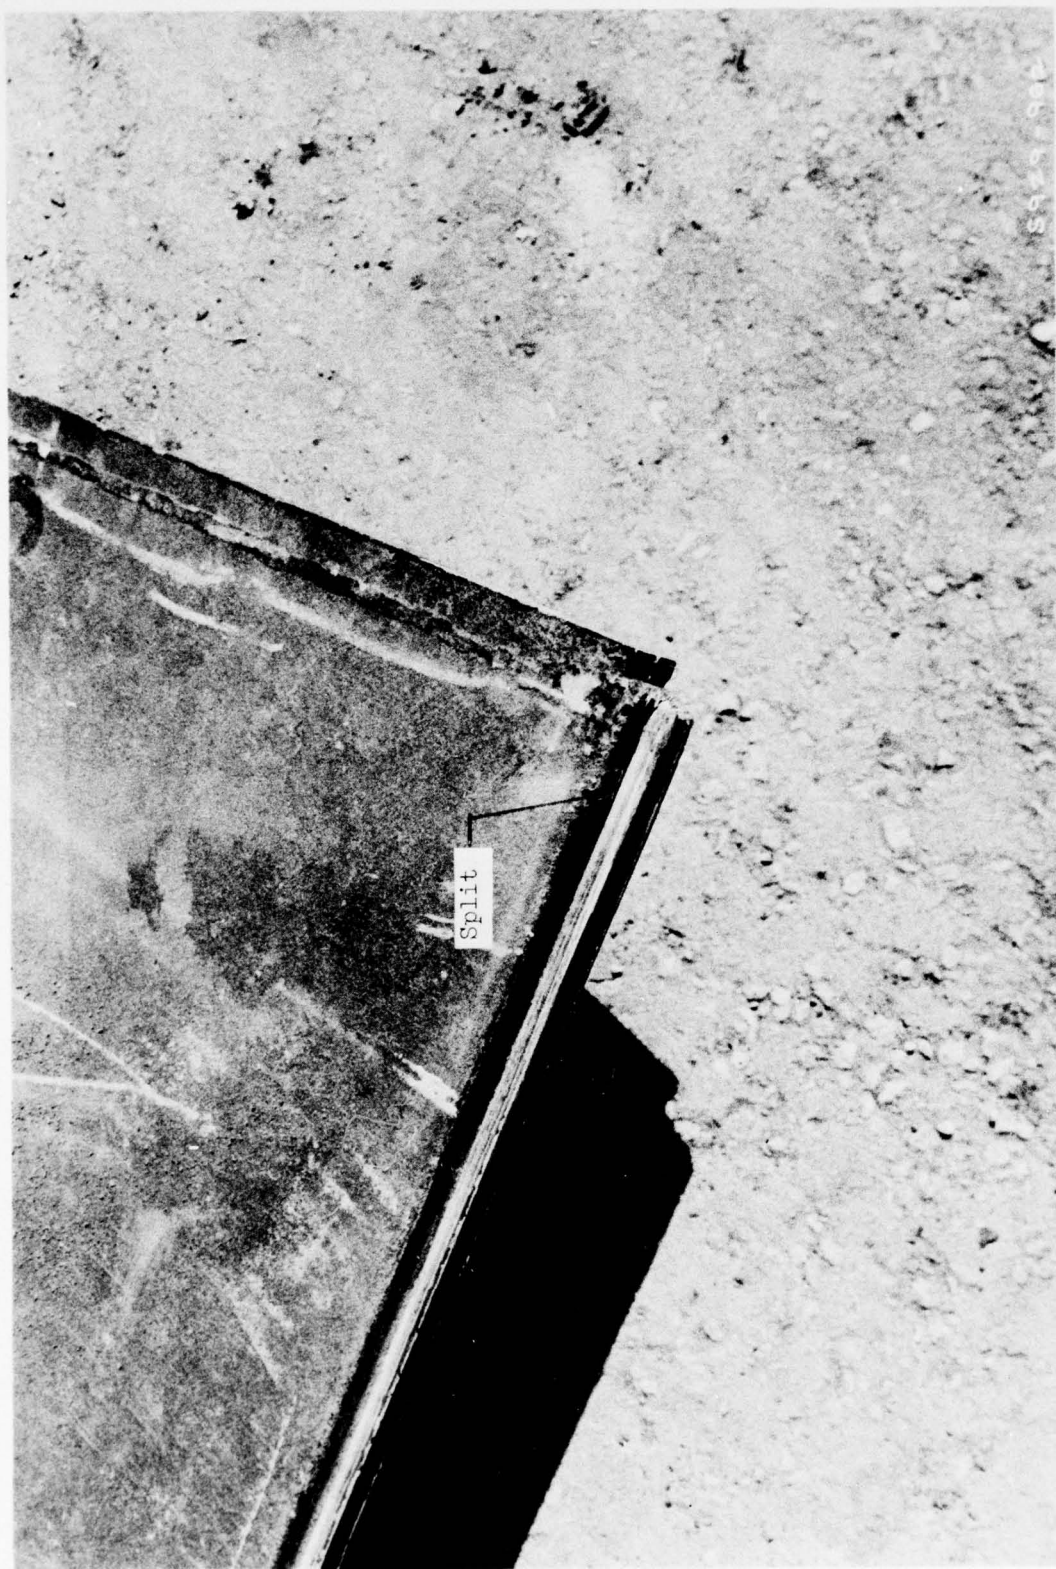
Split in male connector after 300 coverages, Phase 3

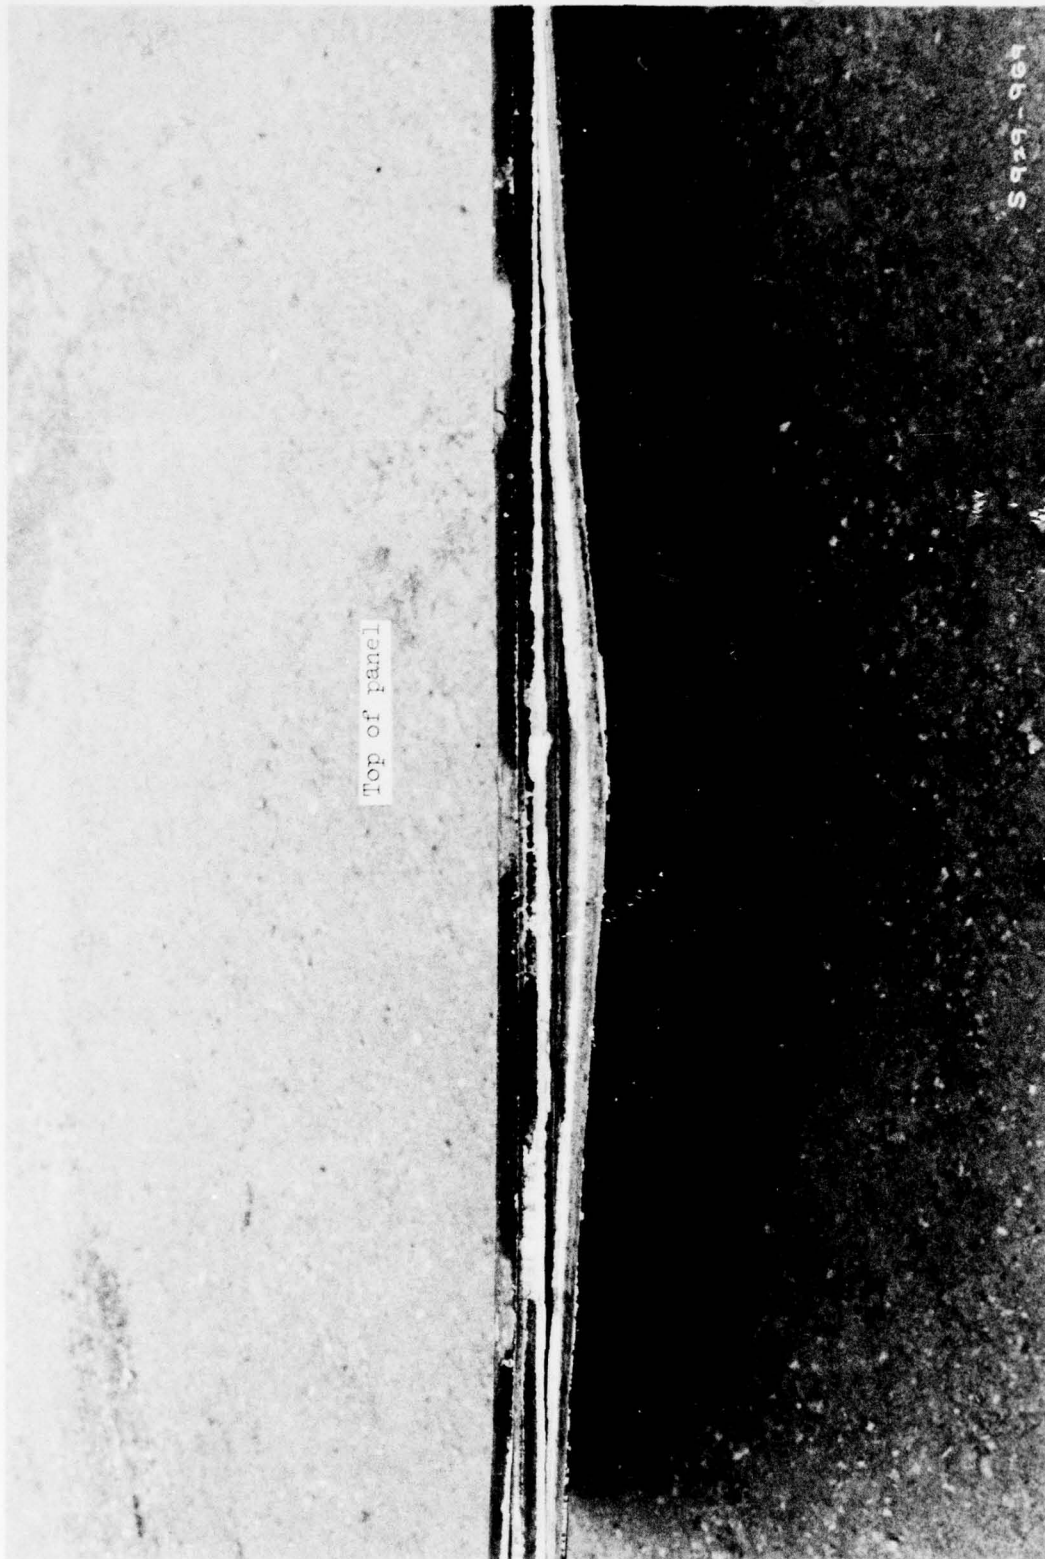
Split in slart rib of the female connector of panel 2 after 300 coverages, Phase 3

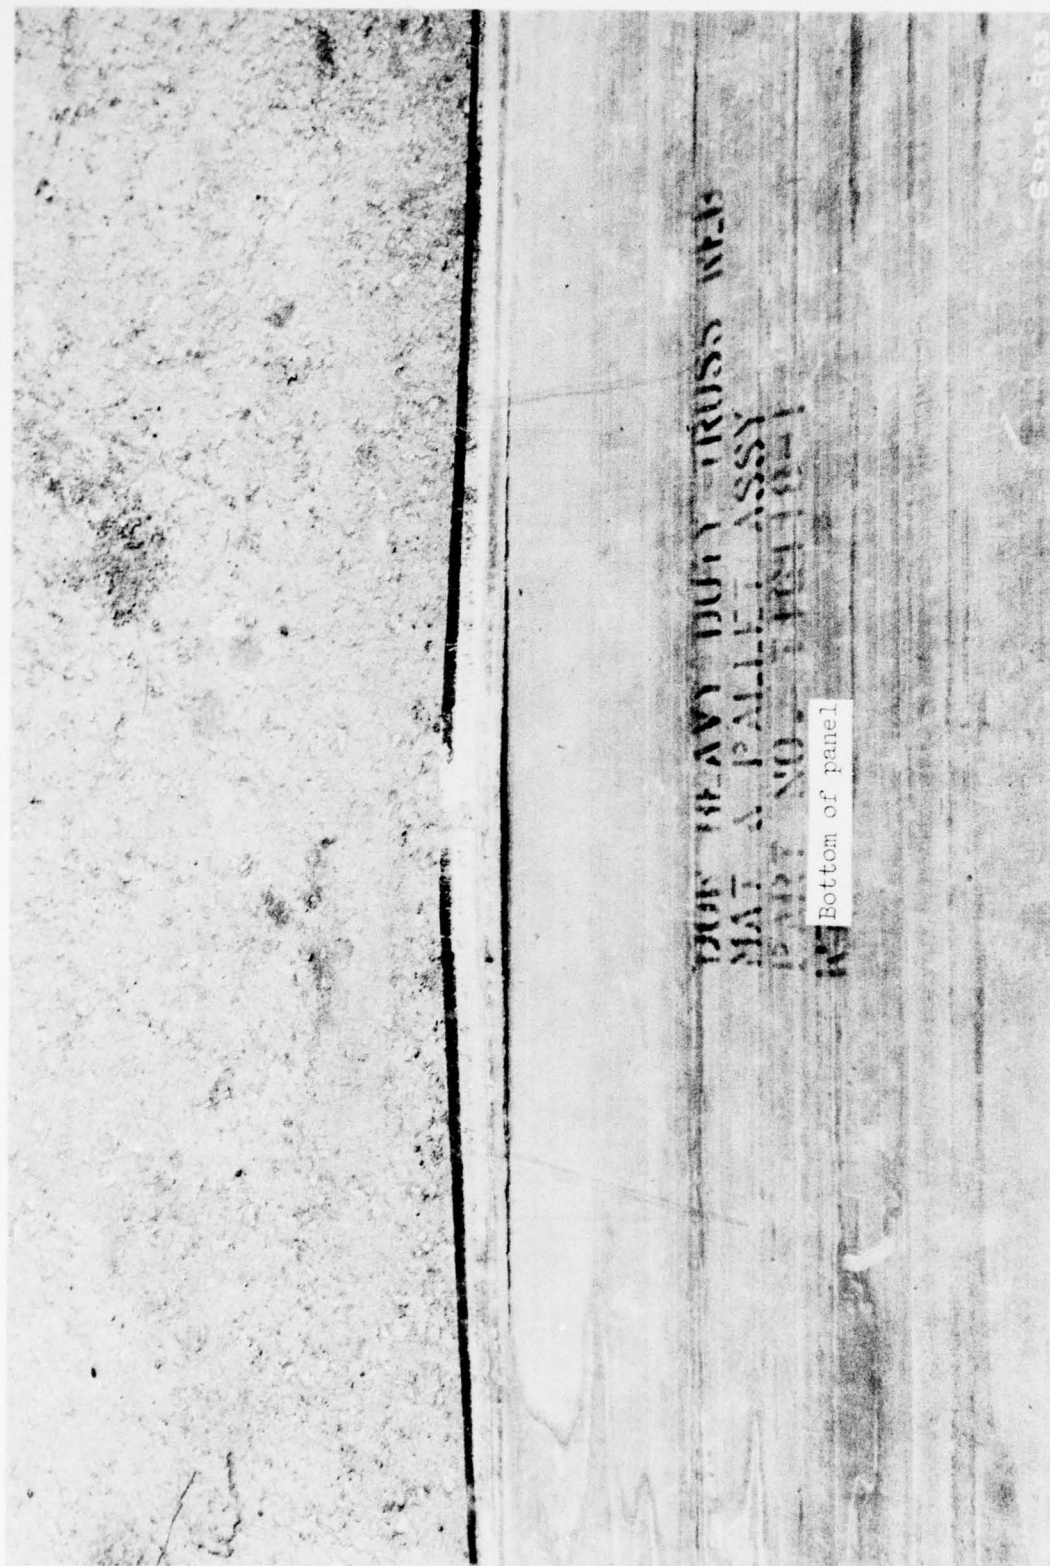
Split in bottom of panel 2 near the female connector after 300 coverages, Phase 3
